Evaluation of the Impact of Landfill
Leachate on Ground-Water Quality at the
Lexington County, South Carolina Landfill Site

South Carolina State Dept. of Health and
Environmental Control, Columbia

Apr 80

EPA 904/9-80-050
April 1980

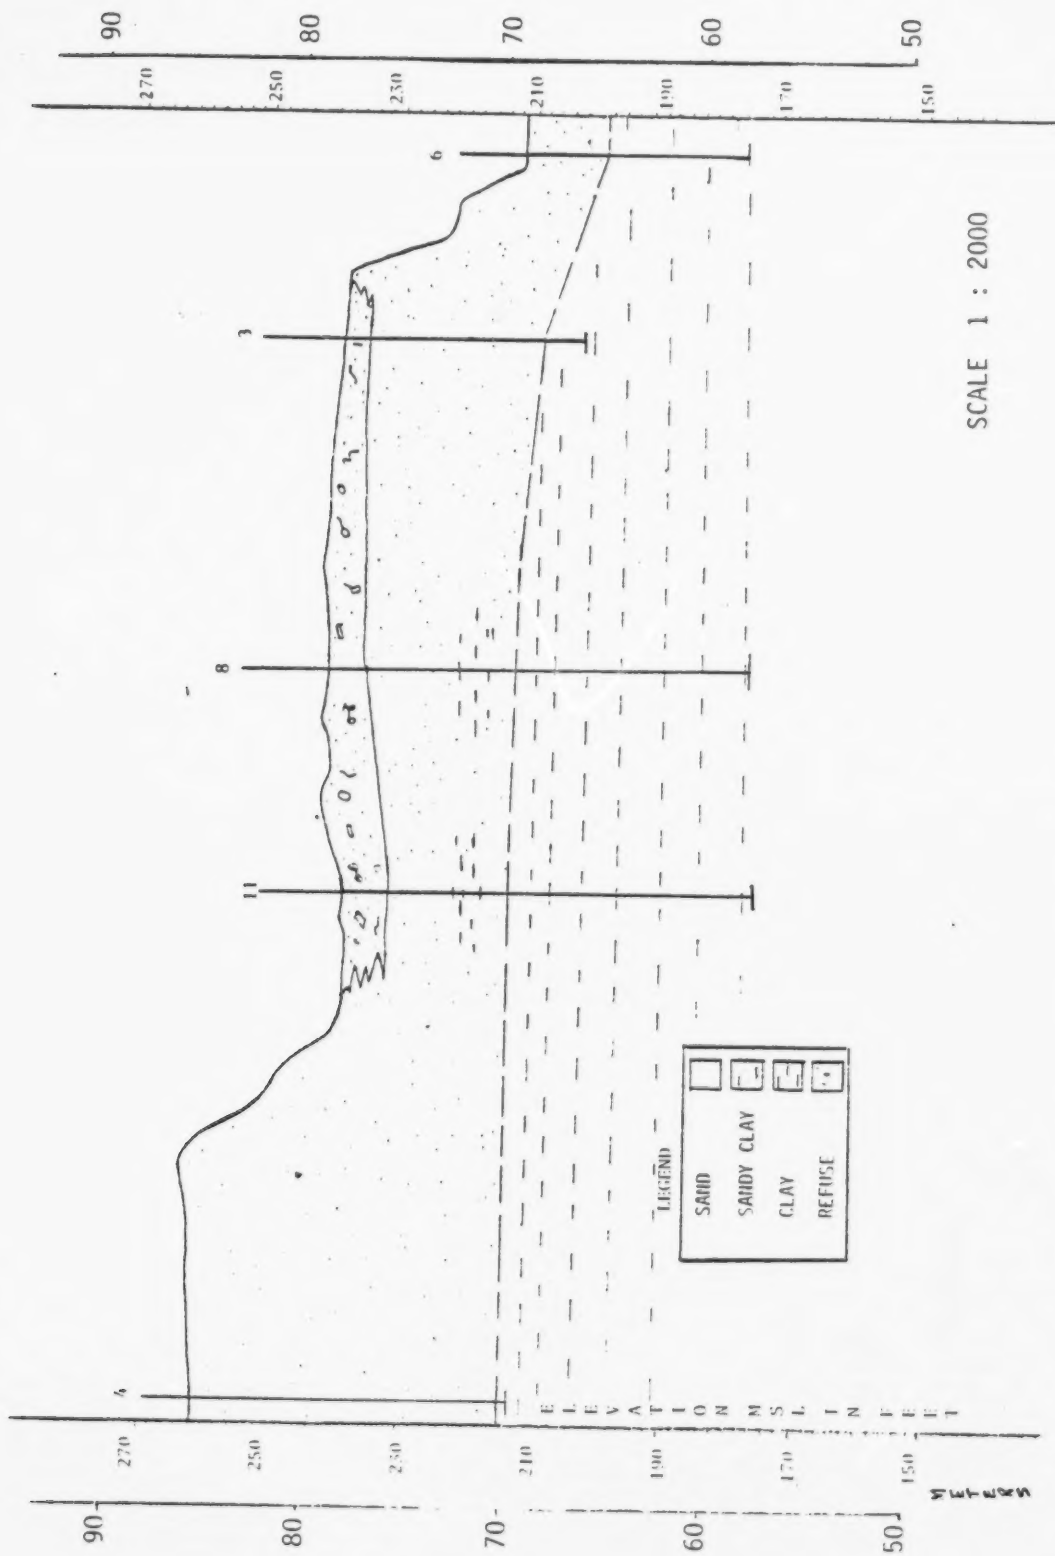
Figure 6. Cross-section X-X' from stratigraphic test 4 to monitoring well 6.

Cross section (X-X') illustrates lithologies east of the landfill and OCD (see Figure 6). The oldest unit is a very pale (5YR 8/2) to grayish orange (10YR 7/14) clay intercalated with a medium to coarse

light brown (5YR 5/6) sand averaging 35 feet (10.7 meters) below the surface. This clay is considered to be part of the Middendorf Formation. Individual sand units within this formation could not be correlated indicating they are irregular or pinch out at relatively short distances.

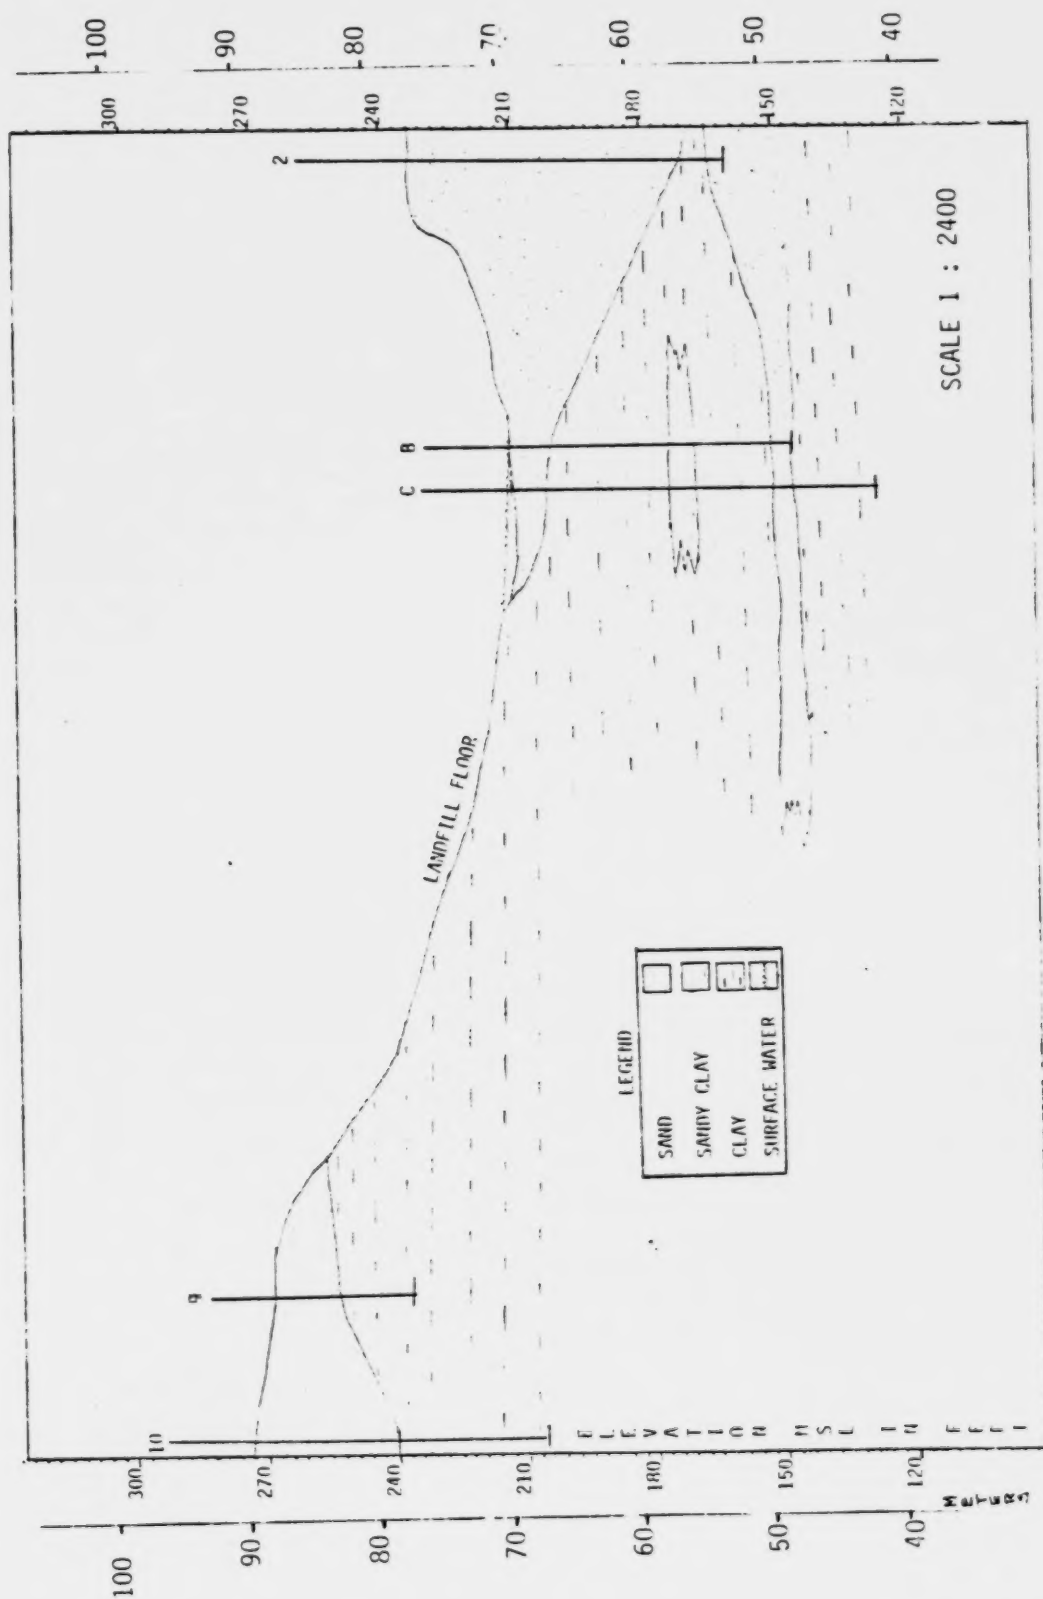
Figure 7. Cross-section W-W' from stratigraphic test 9 to monitoring well 2.

Cross section W-W' illustrates lithologies associated directly with the LCL (see Figure 7). A pink to grayish orange (10 YR 5/6) clay intercalated with a light brown (5YR 5/6) medium to coarse-grained sand underlies the landfill and is exposed on the eastern floor.

On the southern end overlying this clay is an off-white (N8) medium to coarse-grained sand. This light brown (5YR 5/6) sand with thickness up to 60 feet (18.3 meters) can be observed along the walls of the landfill on the east and west sides. On the northern end the medium to coarse-grained sand reaches thicknesses averaging 32 feet (9.8 meters) as indicated by borings #9 and #10.

During the period of study, waste material was deposited on the clay floor on the west side of the landfill. Previous well E (since abandoned) indicated 12 feet (3.7 meters) of wastes on the southwest end. At this time the estimate is 25 feet (7.6 meters) at that point. No other data on waste thickness are available. The cover for the landfill is a light brown (5YR 5/6) medium to coarse-grained sand.

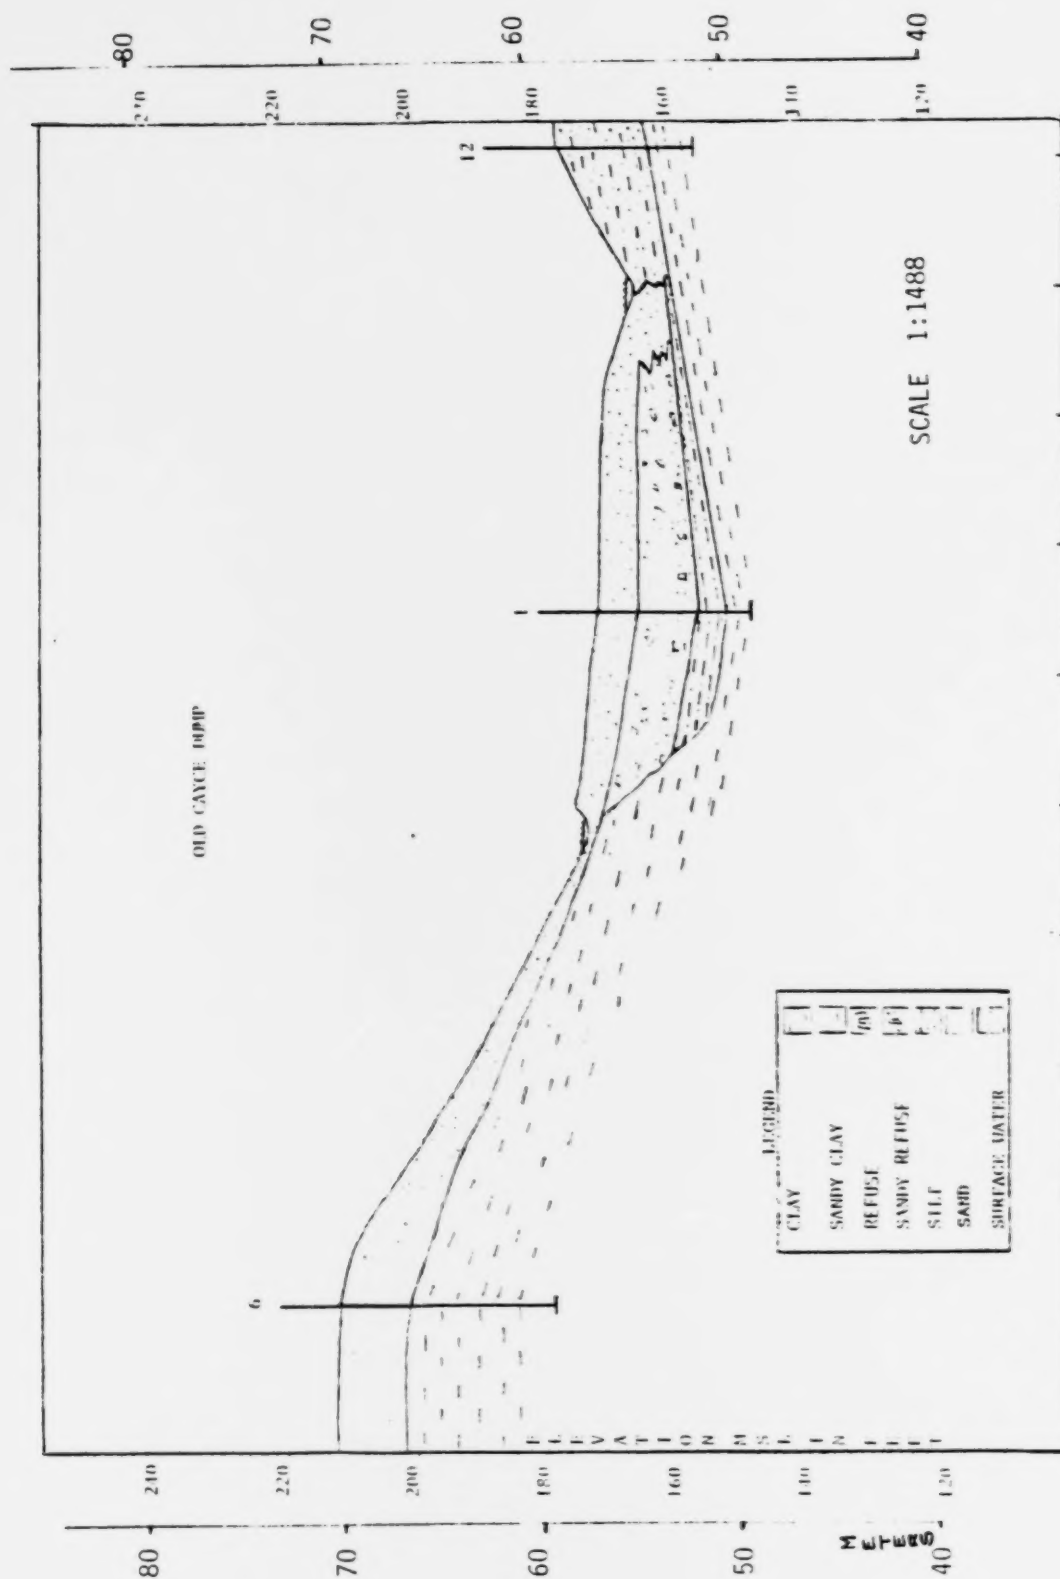
Figure 8. Cross-section Y-Y' from stratigraphic test 12 to monitoring well 6.

The cross-section through the OCD (Y'-Y) illustrates subsurface lithologies of the Stanley Pond area (see Figure 8 supra). The pond itself was turned into a trash dump in the mid 1960's. Drilling showed a pale-orange (10YR 8/2) slightly plastic clay of unknown thickness averaging 16 feet (4.9 meters) below the surface. Overlying this unit, in the vicinity of monitoring well #6 east of the OCD is a coarse-grained yellowish-orange (10YR 6/6) sand, 8 feet (2.4 meters) in thickness. To the west, stratigraphic boring #12 indicated 15 feet (4.6 meters) of sandy clay overlying the clay.

Lithologies were much different in the dump area where Stanley Pond once existed, as indicated by stratigraphic boring #1. Overlying the pale-orange (10YR 3/6) clay is a 4-foot (1.2 meter) thick dark organic-rich silt, which may have been deposited at the bottom of Stanley Pond. Overlying the dark silt was 10 feet (3 meters) of black highly decomposed waste material which was covered by a 7-foot (2.1 meters) layer of medium-grained light-brown (5YR 6/4) sand.

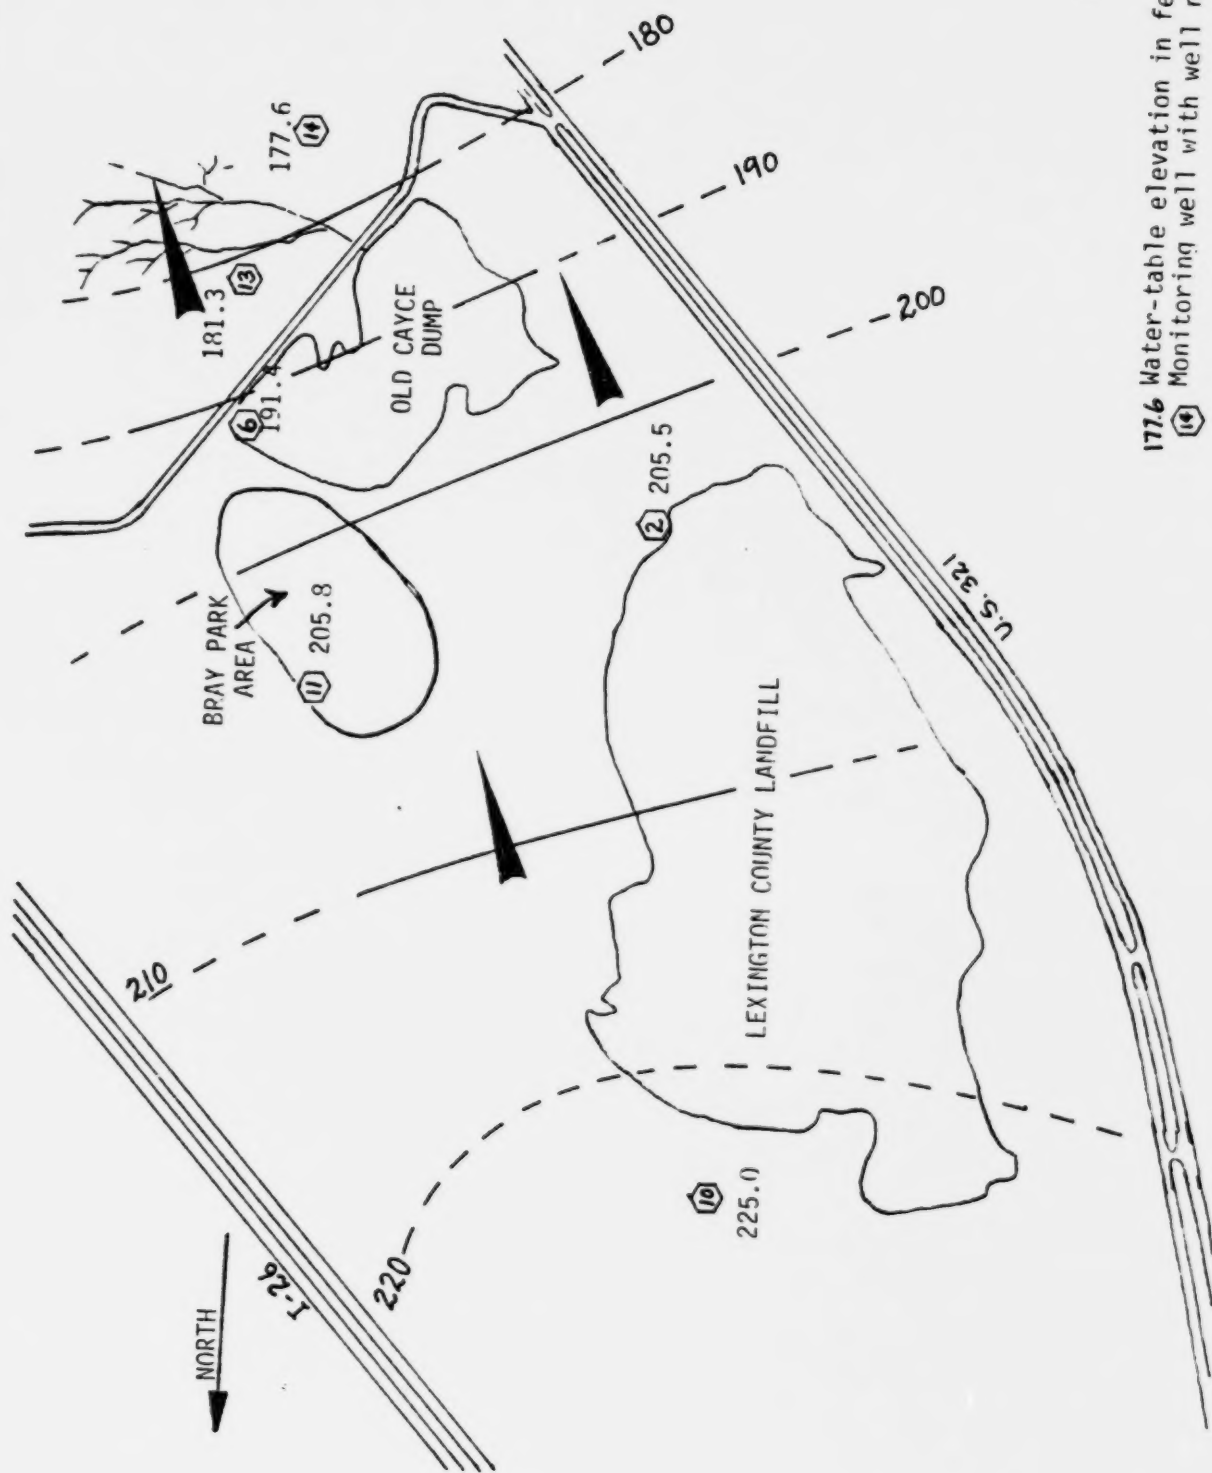
Figure 9. Water-table surface measured on July 7, 1978. Contour lines dashed where inferred. Arrows indicate probable flow direction.

Shallow Ground Water Hydrology - Water-level data from monitoring wells and points of spring emergence give a varying and complex hydrologic picture of shallow ground-water flow in the study area. Water levels measured in wells #2, #6, #11, #13, and #14 indicate water-table flow is in a south-southeasterly direction through the LCL and the OCD

(see figures 9 and 10 supra). J. Michel stated that the flow of ground water from the LCL is radial, but this cannot be confirmed without a more extensive shallow well network.

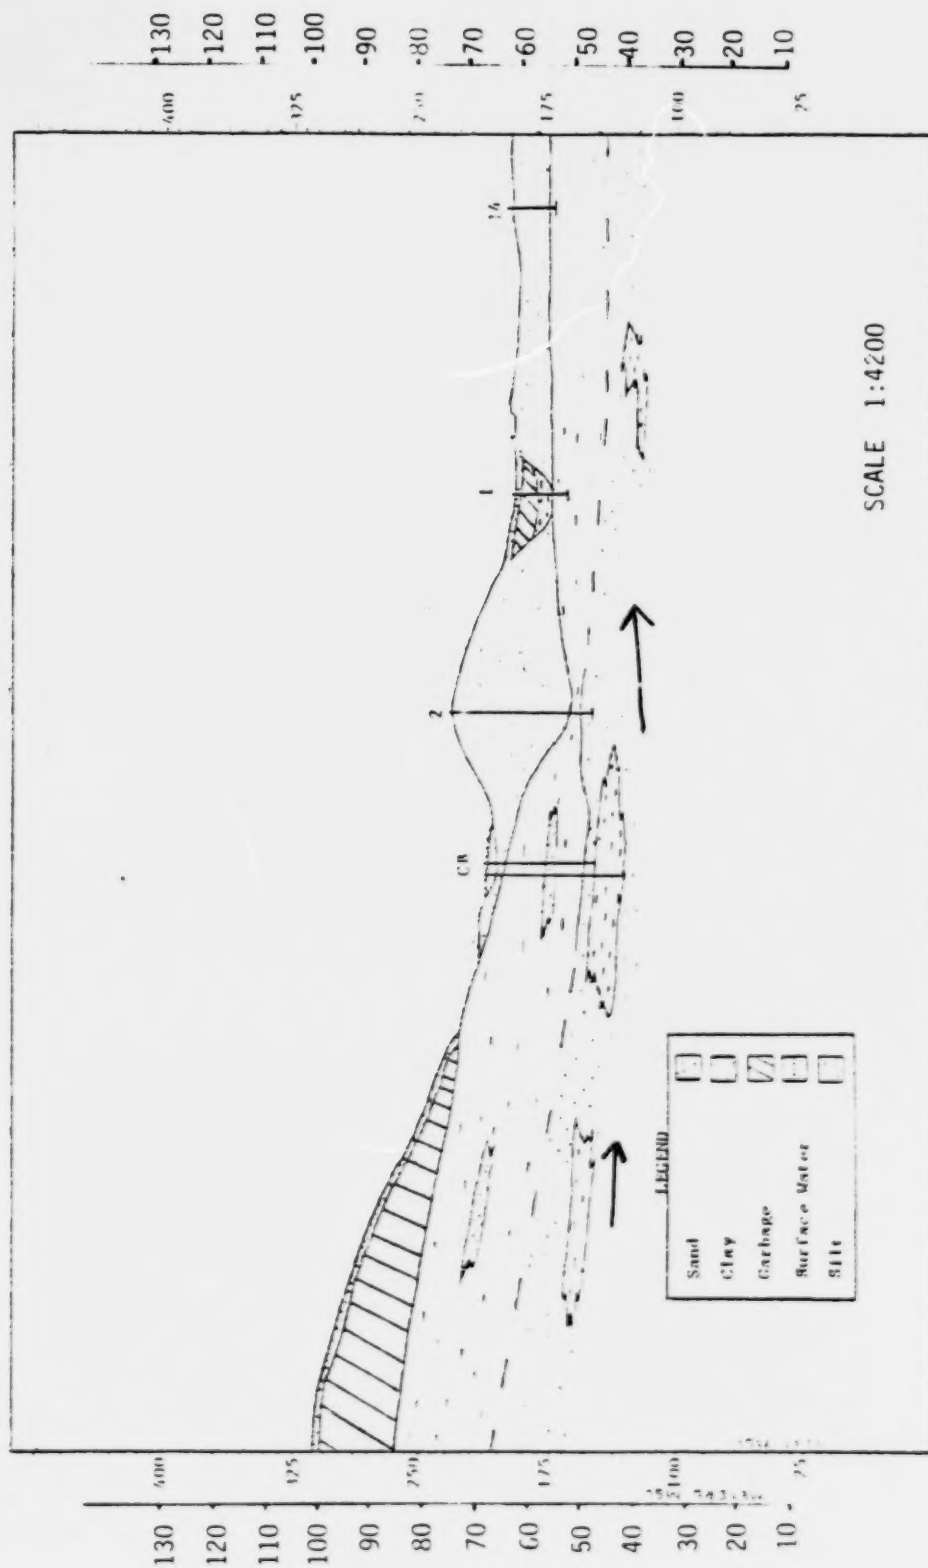
Figure 10. Cross-section Z-Z' from the northern edge of the Lexington County Landfill to monitoring well 14.

Drill logs indicate a basal clay of unknown thickness beneath the LCL and the OCD (see Figure 10 supra). Even taking into account the heterogeneous nature of the Middendorf Formation, the continuity of this clay in the OCD area appears very probable. Ground water emerging from the OCD probably is caused by rain percolating through sand and waste material in the LCL area and traveling laterally on top of this basal clay, which is within about twenty feet (6.1 meters) of the surface in the vicinity of the OCD.

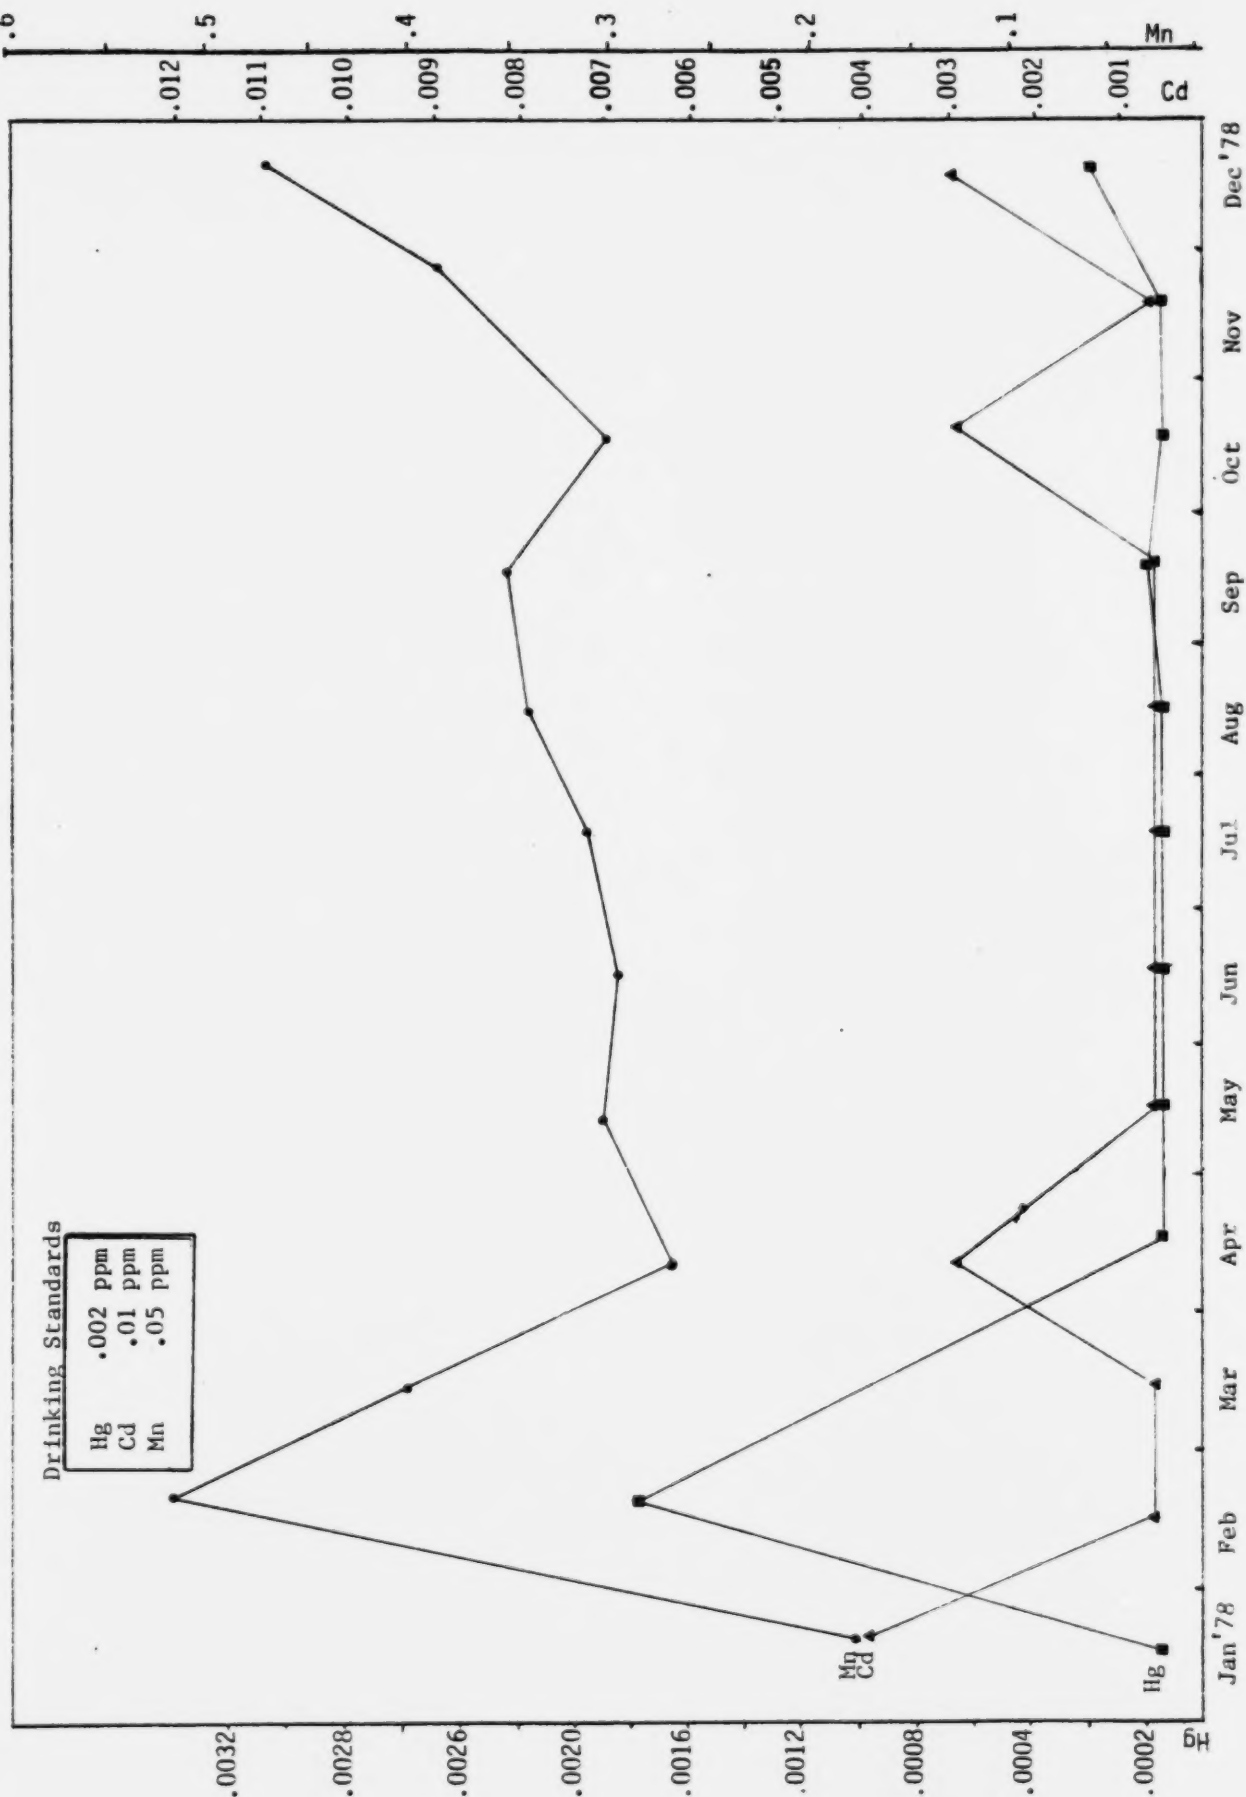
Figure 12 Water quality trends from filtered samples for Cadmium, Manganese, and Mercury in parts per million

DHEC well #2 located between the LCL and the COD as recommended by J. Michel is assumed to represent leachate quality horizontally leaving the LCL (see Figures 12 through 17). The most significant water-quality changes are elevated conductivity and chlorides which approached drinking water standards (see bottom) once during the period of study. The elevated iron and manganese may be attributed to leachate and/or the dissolving of these metals from the formation between the landfill and well #2. Lead exceeded drinking water standards three times. Hardness, COD, copper, cadmium, chromium and selenium are slightly elevated above background for normal Upper Coastal Plain shallow ground water. In general the concentration of dissolved material in well #2 appears to be a function of precipitation (increased precipitation produces greater volumes of more dilute leachate). Leachate leaving the LCL is probably localized and restricted to the water table aquifer and shallow ground water entering the OCD may be previously contaminated by the LCL.
